Water Compliance Inspection Report

**NPDES
Inspection Report**

**Dan Noteboom Dairy
Lynden, Washington**

March 29, 2010

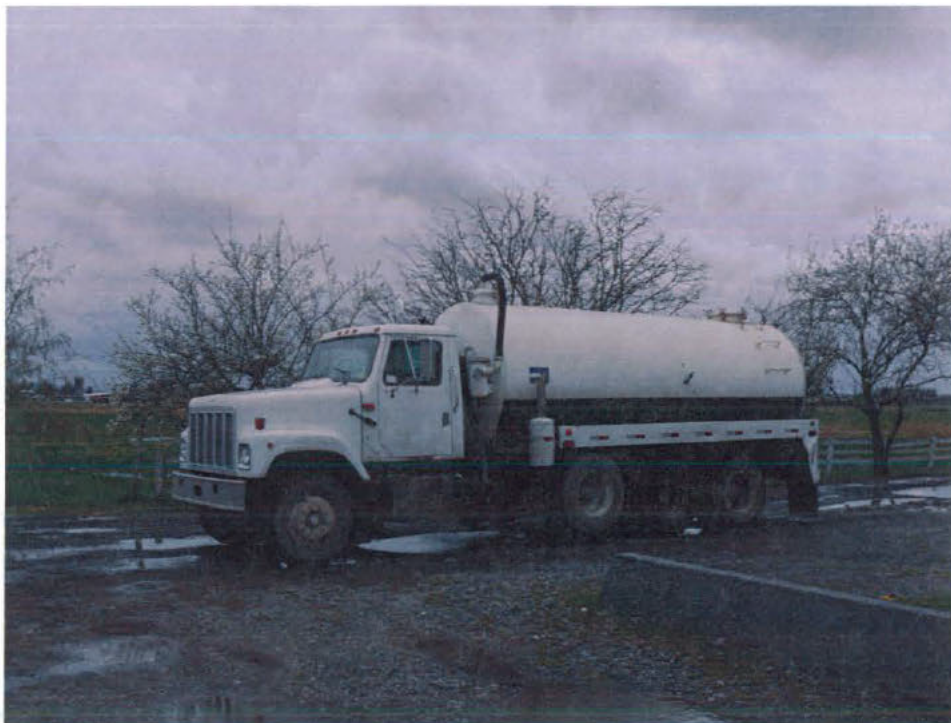
Photo #10: View of the truck used to land apply wastewater as well as transfer wastewater between the waste storage lagoon at the main facility and the waste storage lagoon at the Hannegan Road location.
